FORESTRY TRANSPORTATION ACCIDENT & PREVENTIVE MEASURES BOOKLET

TEAM SAFE TRUCKING 2022

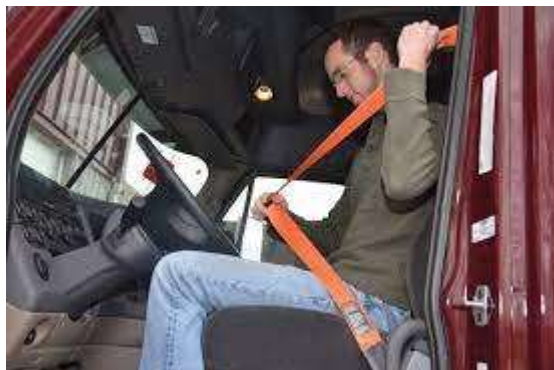
3. SEATBELT ACCIDENT-FATALITY

A subcontract hauler was heading to the mill, fully loaded. Still traveling on a forest road, the driver came to a single-lane bridge at the bottom of a long incline. The driver apparently had control issues just as he was about to engage the bridge; his right front tire hit the approach guardrail. The driver reacted by pulling sharply to the left. The truck veered over top of the bridge and came to rest down the embankment.

Log truck driver did not have insurance. He asked to have his insurance coverage suspended due to the lack of work at the time. He did not reactivate coverage even though he was taking on "small" jobs. There were several mechanical issues including steering hardware. The tractor and trailer had suspension issues. Excessive speed, coupled with slippery road conditions, were also likely factors to the crash. The logger did not request current proof of insurance beforehand. Adding to the dilemma, no contract was in place. The logger said he only needed the extra truck for two or three days while one of his rigs was in for repair. The logger was held liable.

Loggers need to understand the risks when hiring contract haulers. Complete Team Safe Trucking's Multi-contractor & Liability course. When working on a job that involves multiple contractors, it is important that all parties working supply a certificate of insurance.

Ensure Subcontractors have safety and training programs/policies, review these and based on this review have them comply with your companies or approve theirs. All contractors should be pre-qualified, trained and commit to complying with multi-contractor safety policies and procedures. Observe and enforce contractors and employees working for compliance with safety policies and procedures. Post Signs where they can be easily viewed.

Provide training on hazards and preventive measures. Then hold contractors accountable. Enforce rules! Plan for and use disciplinary action for contractors that break rules. Disqualify contractors that do not meet minimum safety requirements.

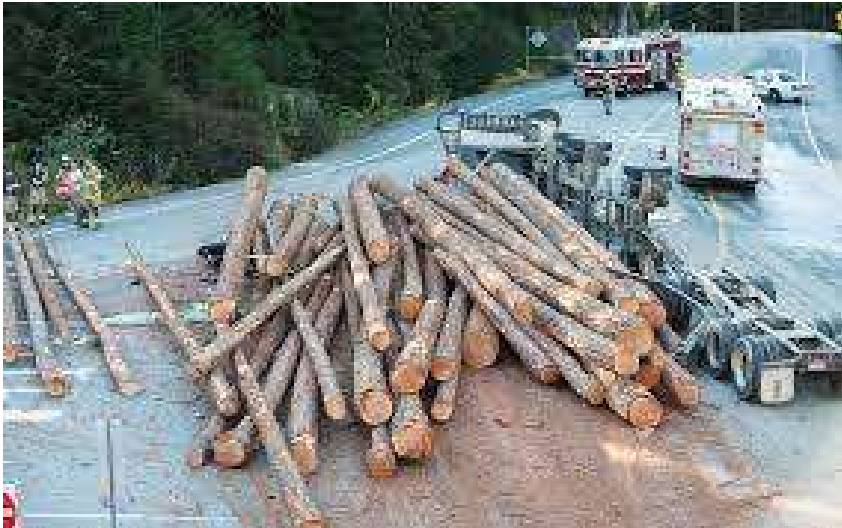
5. ROLLOVER FATALITY

A 60-year-old Chisholm man died after the fully loaded logging truck he was driving crashed in rural St. Louis County on Tuesday evening, authorities said.

He rolled the truck at the intersection at 6:15 p.m., according to the Sheriff's Office. A passerby called 911 to report the crash.

"The driver was not wearing a seat belt at the time of the accident and was partly ejected from the vehicle," the Sheriff's Office said in a news release.

Log truck driver not wearing a seatbelt.

Reduce speed when turning or on curves to reduce rollover risk. Maintain a speed below the advisory speed, these speeds are for automobiles. Be aware that log trucks have a high center of gravity and turning too quickly can cause a rollover.

Speed and steering must be fluid to successfully handle a turn or curve. The way to best take a corner is to greatly reduce speed, prior to entering a cornering situation. The vehicle must be reduced while it is straight and before entering the curve. Keep your rig and trailer track in your lane.

- gripping the steering wheel too tightly.
- Removing both hands from the steering wheel.
- Removing either hand from the steering wheel for an unnecessarily long time (changing gears).
- Allowing hands to drop to the lower half of the steering wheel. Turning the steering wheel too much or too little or maintaining a turn too long.
- Seat belts should always be worn when a unit is in motion.

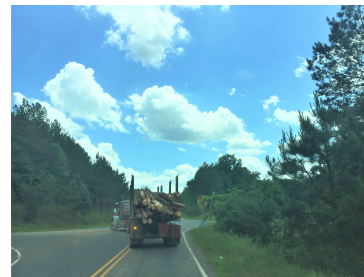
PREVENTION 2

Have your drivers signal their intentions to turn left early, before they start slowing down

Check side mirrors to ensure following traffic (look behind you), has not entered oncoming traffic lane and established right-of-way to pass you.

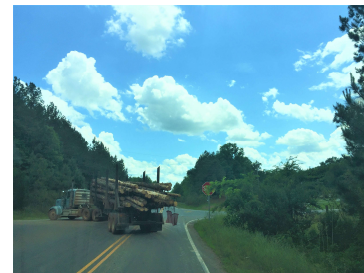
PREVENTION 3

Make left hand turn into woods once you have verified there is no traffic in opposing lane (sides), oncoming (front) or following (rear).

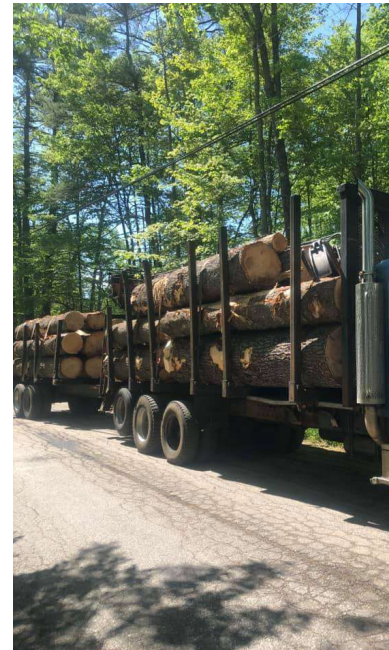
7. CONTRACTOR PULLING YOUR TRAILER

An autopsy was completed on the 31-year-old, who was killed when a wheel detached from a logging truck trailer struck him as he assisted a driver alongside the Interstate.

- Inspect tires for proper tread depth.
- Ensure wheels are secured
- Inspect bolts or studs that hold the wheels together on an axle
- Look for hairline cracks near brake shoes

- Conduct daily pre-trip inspections on trucks and trailers.
- Ensure not to overload log trailers.
- Inspect tires for proper tread depth.
- Ensure wheels are secured
- Inspect bolts or studs that hold the wheels together on an axle
- Look for hairline cracks near brake shoes

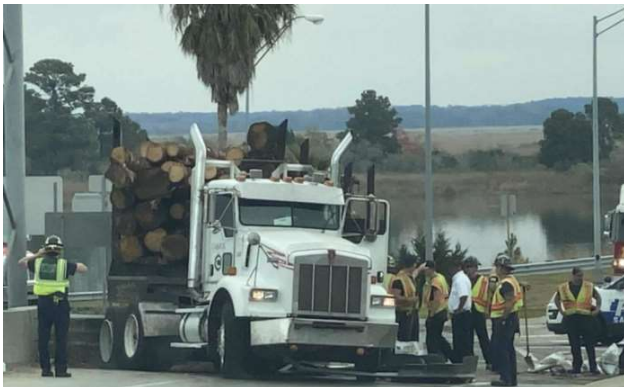
9. STEERING WHEEL COMES OFF – MECHANICAL FAILURE

The log truck was traveling south when the steering wheel came completely off. The driver then lost control of the truck and crashed into the concrete bridge, ejecting him from the rig. The truck then continued rolling south before eventually striking the guardrail at the bottom of the Bridge and coming to a stop.

A log truck driver was ejected on Tuesday after experiencing a serious mechanical failure that caused him to crash.

A pre-trip inspection or reporting steering issues to the mechanic and having the repairs made when they were first recognized by the driver.

Wearing a seatbelt prevents drivers from being ejected from vehicles. Developing policies and procedure to be sure drivers are complying with the Federal Regulations and Companies Policies.

Discussing other ways to stop the out-of-control log truck if the steering wheel does become attached could have helped prevent the accident. Discuss the need for carrying spill kits in log trucks in the event of spills. There was a 150-gallon diesel fuel spill on the bridge following the crash.

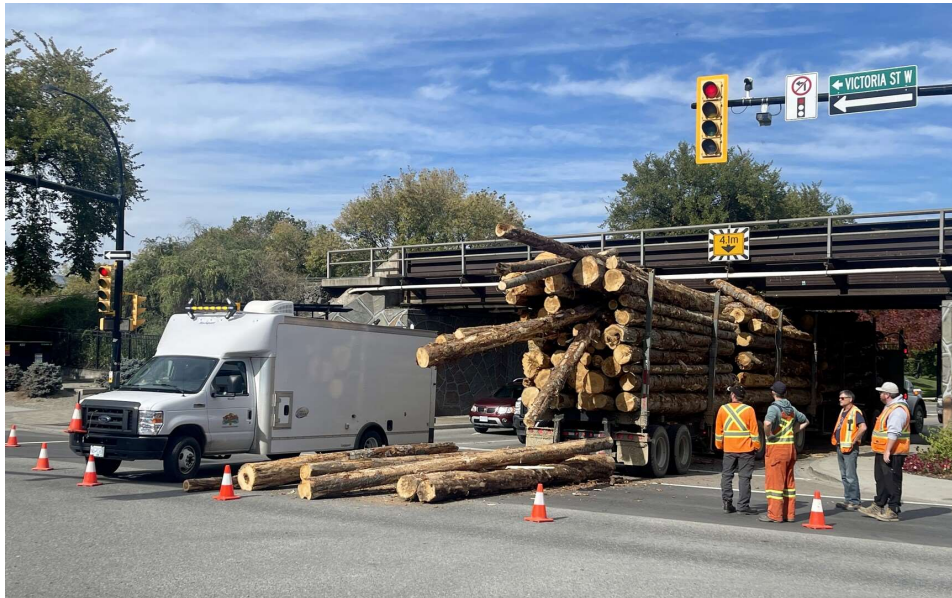
10. LOG TRUCK STRIKES BRIDGE

Logs spilled on First Avenue after logging truck's load strikes rail overpass near city hall. The truck is believed to have become wedged beneath the bridge sometime before 1 p.m. Emergency crews were called to the scene at about 1:15 p.m.

Clear day.

Realize the height of your load, bunkers, and loader before you leave the landing zone. Check routes prior to heading out delivering logs.

Stay alert to signs and clearances on overpasses and bridges.

If you are re-routed...Stop! Check alternative routes and be sure that you are not going to have any clearance issues on the new route.

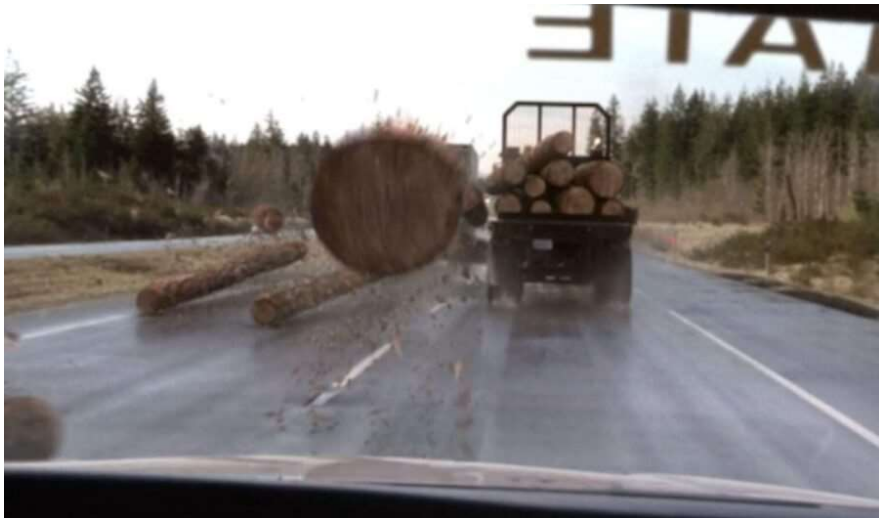
11. DRIVER KILLED – SPEED

The driver of a logging truck involved in a single-vehicle crash on Highway 1 Thursday has died.

According to Richmond County coroner Mark Bowen, a logging truck was transporting a load northbound on Highway 1 when the driver lost control and the truck turned over. The driver was pronounced dead at the scene at 8:10 p.m.

Reduce your driving speed in Adverse Road and or Weather Conditions! Adjust your speed to safely match weather conditions, road conditions, visibility, and traffic. Excessive driving speed is a major cause of fatal crashes, and higher speeds may cause more severe crashes. The Fatality Analysis Reporting System (FARS) recently reported that 25 percent of speeding-related large-truck fatalities occurred during adverse weather conditions.

Enter a curve SLOWLY! 40 percent of speeding-related fatalities occur on curves. Braking in a curve can cause the wheels to lock up and the vehicle to skid.

Reduce your SPEED before Entering an EXIT/ENTRANCE RAMP! The posted speed limit on an exit/entrance ramp generally shows the safe speed for a passenger vehicle; the safe speed for a large truck is usually significantly lower than the posted speed. Even though ramps and interchanges make up less than 5 percent of all highway miles, 20 to 30 percent of all large-truck crashes occur on or near ramps.

Drive slowly with a loaded trailer. Large trucks with fully loaded trailers are 10 times more likely to roll over than those with empty trailers. Slow Down in WORK ZONES! Nearly a quarter of all work-zone deaths in 2006 involved a large truck.

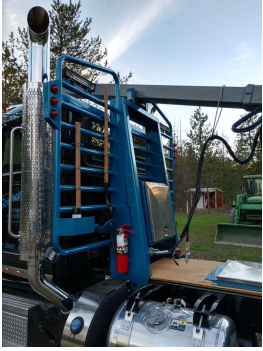
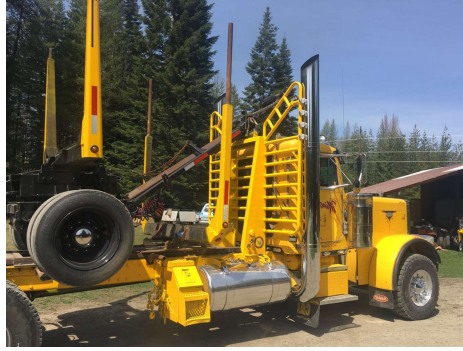
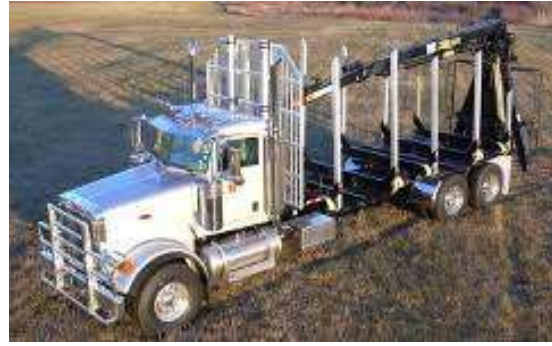
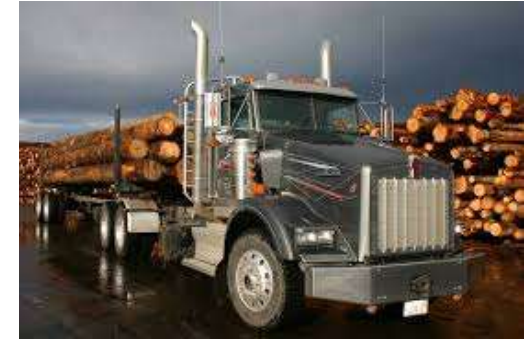
12. ALUMINUM HEADACHE RACK ACCIDENTS

Wrongful Death Lawsuit Filed Over Fatal Logging Truck Accident: The logs on the trailer shifted forward, crushing the cab of the truck. The manufacturer of the cab guard, Merritt Equipment Company, is named as a defendant in the lawsuit.

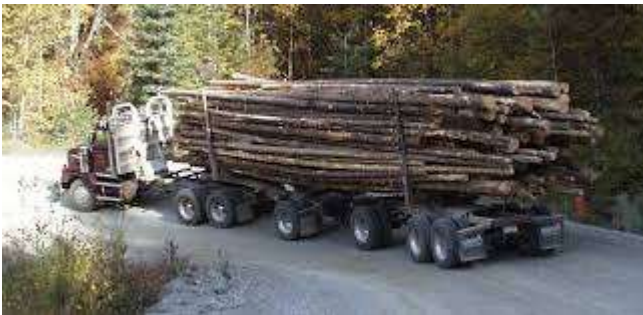
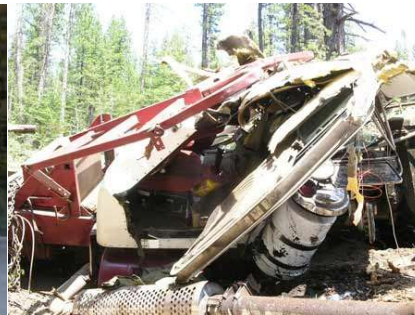
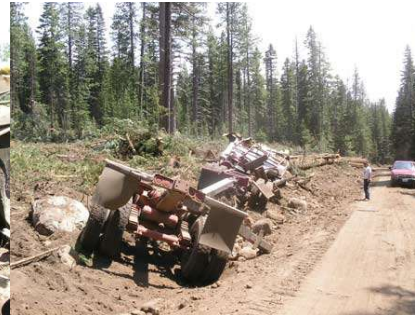
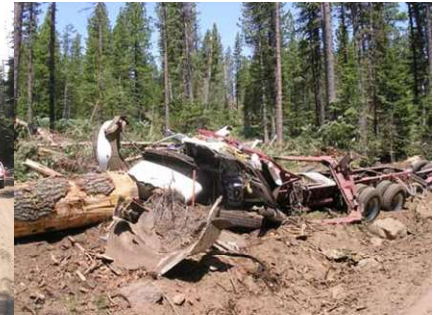
DRIVER AND CONDITIONS: Most log trucks have cab guards or “headache racks.” These guards are used to prevent shifting cargo or logs from encroaching into the cab of the tractor-trailer. Many cab guards are designed from heat-treated aluminum, which can result in the weakening of the cab guard over time. There have been several cases where truck drivers have been injured or killed because of the logs shifting forward in collisions which were otherwise survivable. The manufacturers know these guards will not protect an occupant if the logs shift forward. More shocking is that most of the manufacturers do not test the guards they warrant as safety features for log trucks. Until the manufacturers accept their responsibility to design a safe product, these drivers will continue to be at risk.

Because cab guards are marketed as effective at preventing drivers from being crushed by shifting cargo, thousands of log trucks use them. Few people realize aluminum cab guards are too weak to save a driver's life.

Alternative design would be to use steel since steel will bend and stretch, unlike aluminum, which breaks when not properly engineered. In addition, welded aluminum products are susceptible to fatigue, whereas welded steel products have nearly an infinite fatigue life.

Placing headache racks closer to the load decreasing the force created by the movement of the load.
